# Asbestos Management Plan, Mulga Downs Station, Pilbara, Western Australia

## Mulga Downs Iron Ore Mine – Western Australia

Hancock Prospecting Pty Ltd  
ABN 69 008 676 417

**19 December 2024**

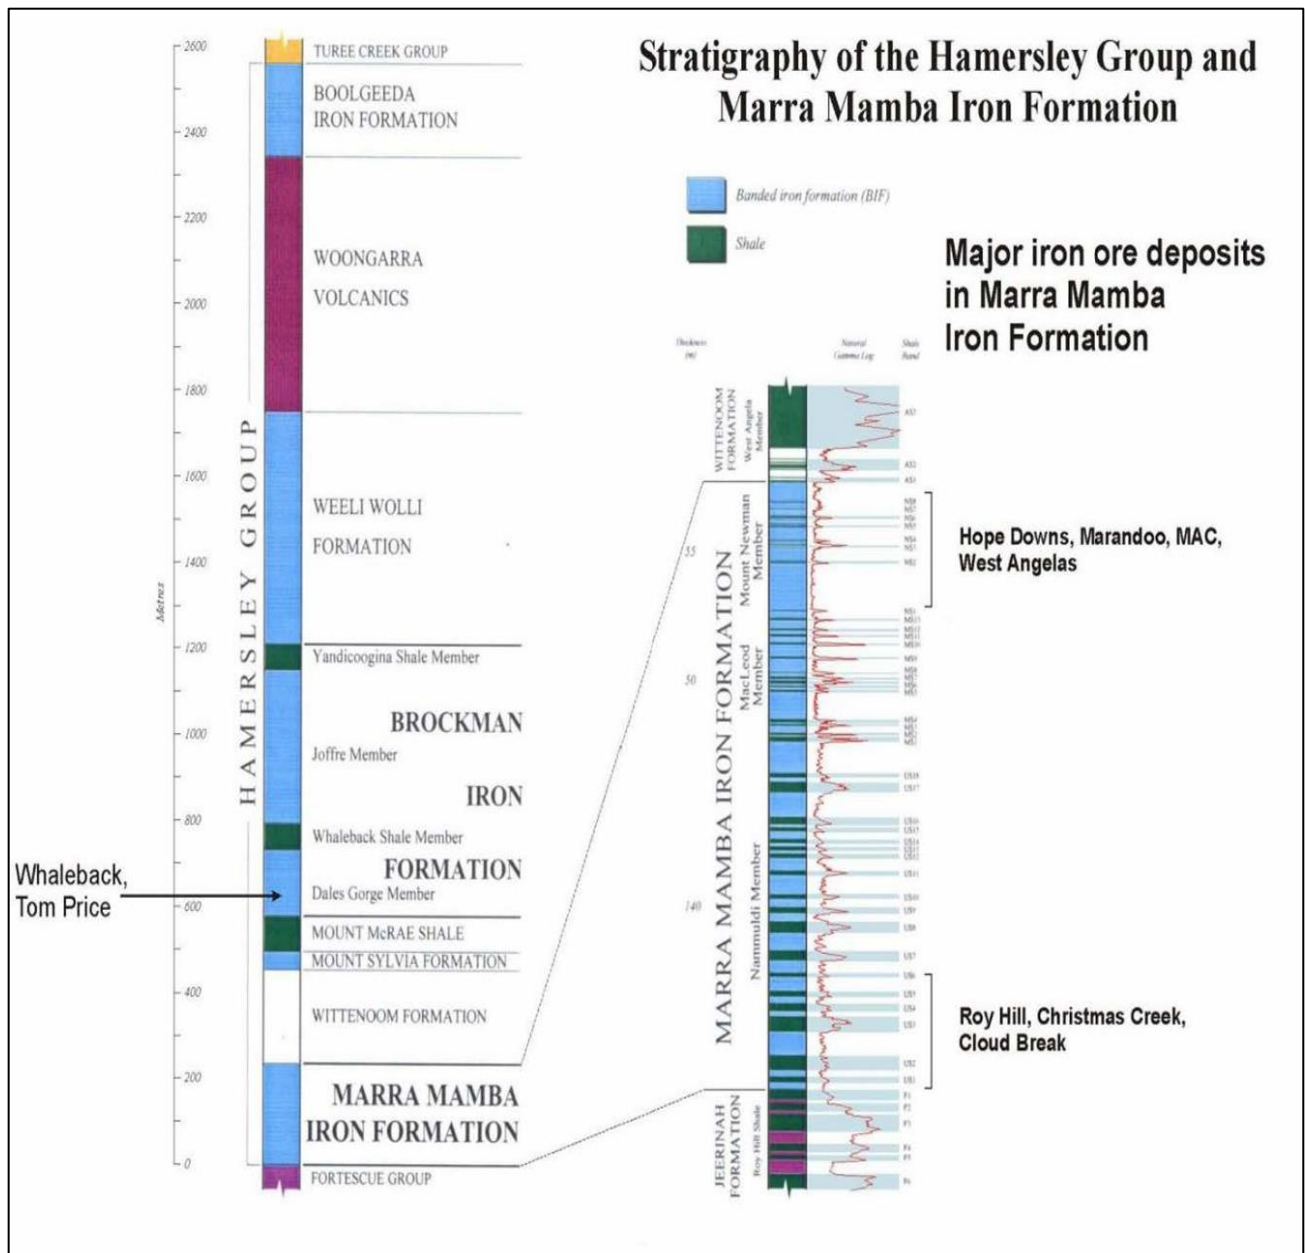
Plate 4-1 Stratigraphy of the Hamersley Group (Source Mine Earth [2022])

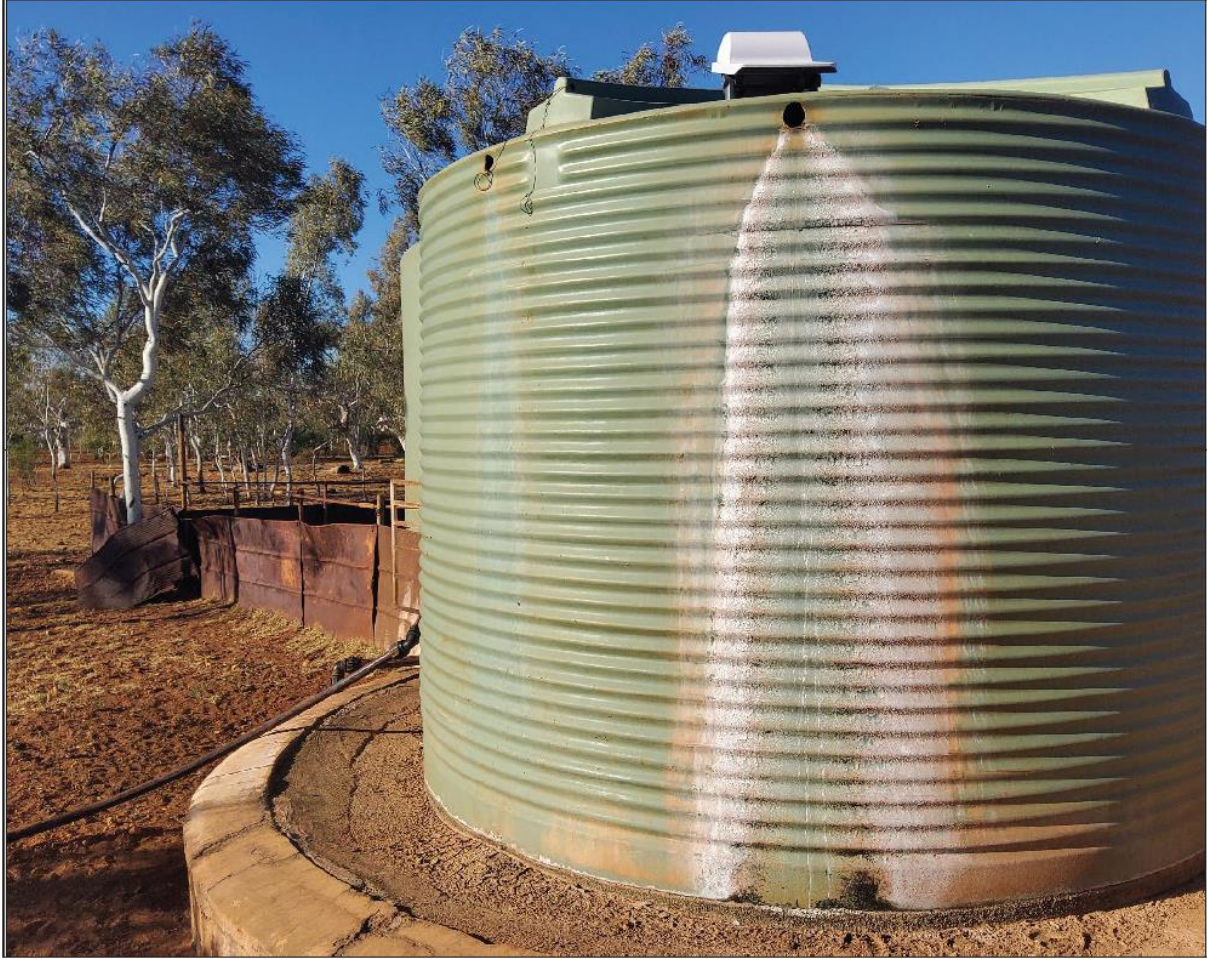
OLD STATION BORE (PACM 3) – ASBESTOS DETECTED

**Visual Inspection –**  
Concrete tank stand,  
evidence of cracking,  
weathering.  
No fencing around  
structure.

**Laboratory Analysis –**  
Crocidolite asbestos  
detected.

- For further information refer to Section 4.4 Tools and Equipment in Work Health and Safety Commission (2022).
- For the decommissioning and/or removal of disused/obsolete structures at Old Station Bore, Murrays Well and Calamina Well, breakage of concrete containing asbestos (bonded asbestos, and there is little free fibre present) will be unavoidable but should be minimised if possible. Use the wet method to remove asbestos where practicable. Further information on the wet method can be found in Section 4.3 of Work Health and Safety Commission (2022).

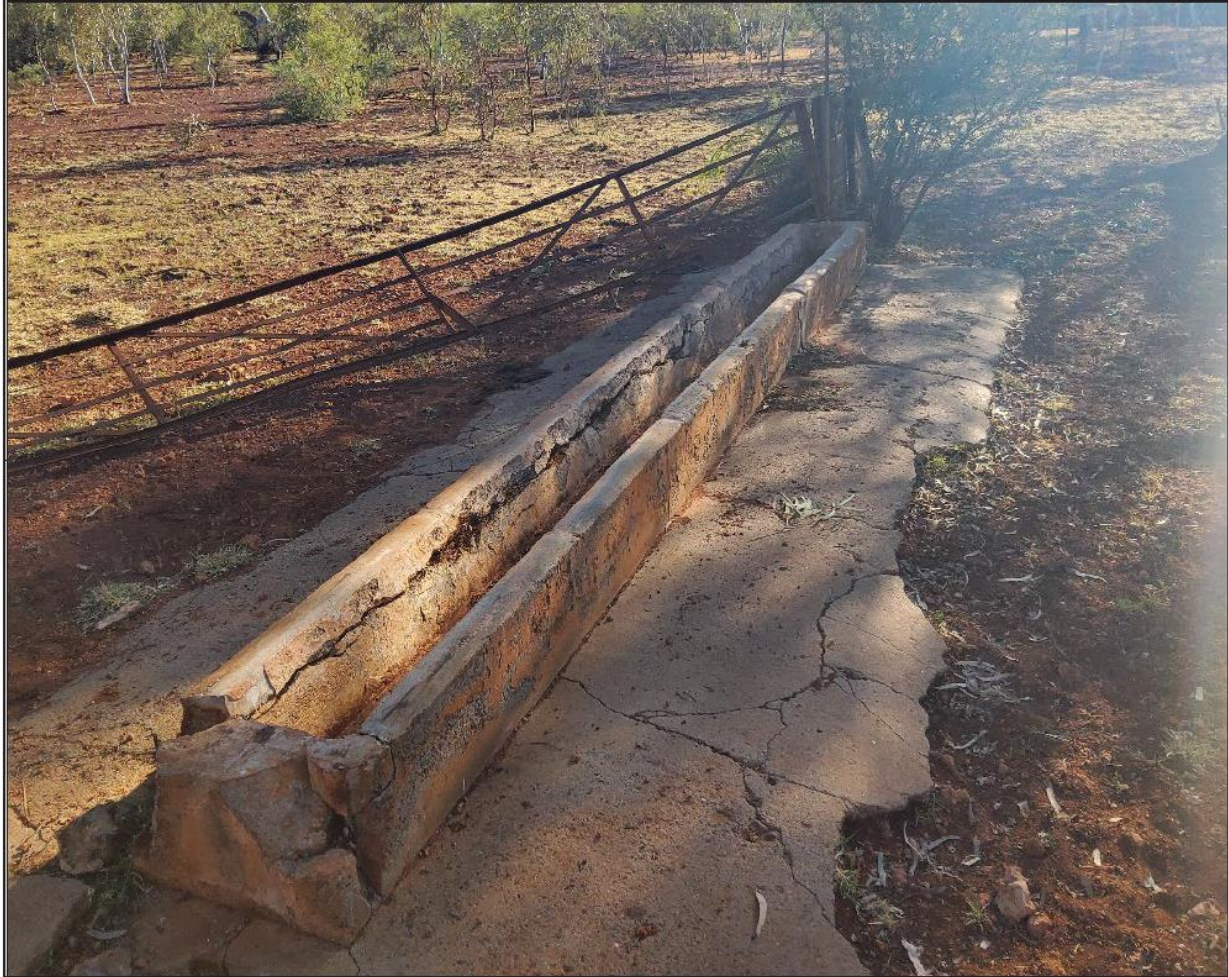
OLD STATION BORE (PACM 3) – ASBESTOS DETECTED

**Visual Inspection –**  
Concrete trough, evidence of cracking, weathering. Potential ACM present. No fencing around structure.

**Laboratory Analysis –**  
Crocidolite asbestos detected.

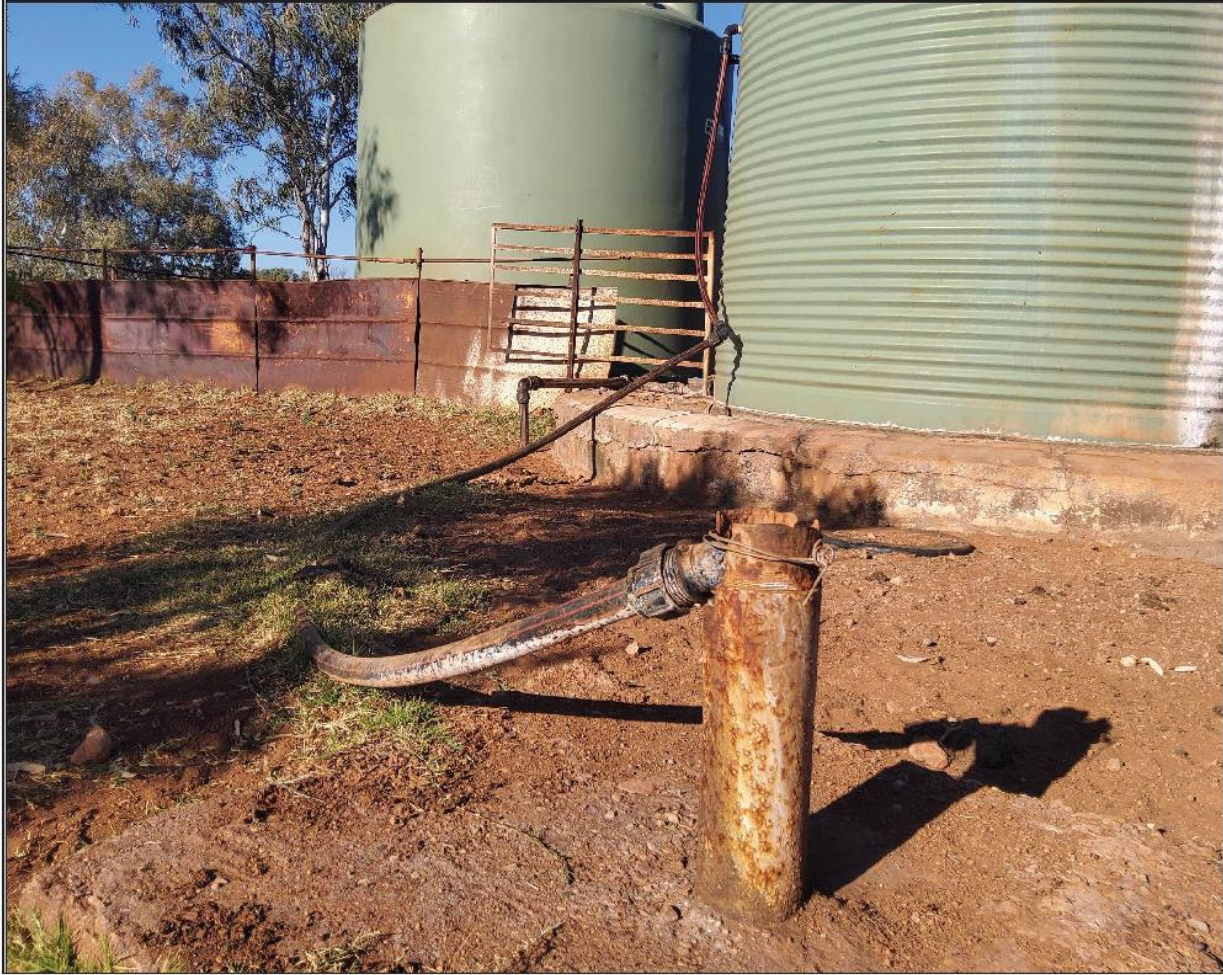
OLD STATION BORE (PACM 3) – ASBESTOS DETECTED

**Visual Inspection –**  
Background two storage tanks. Foreground Bore but no ACM identified.

**Laboratory Analysis –**  
Crocidolite asbestos detected.

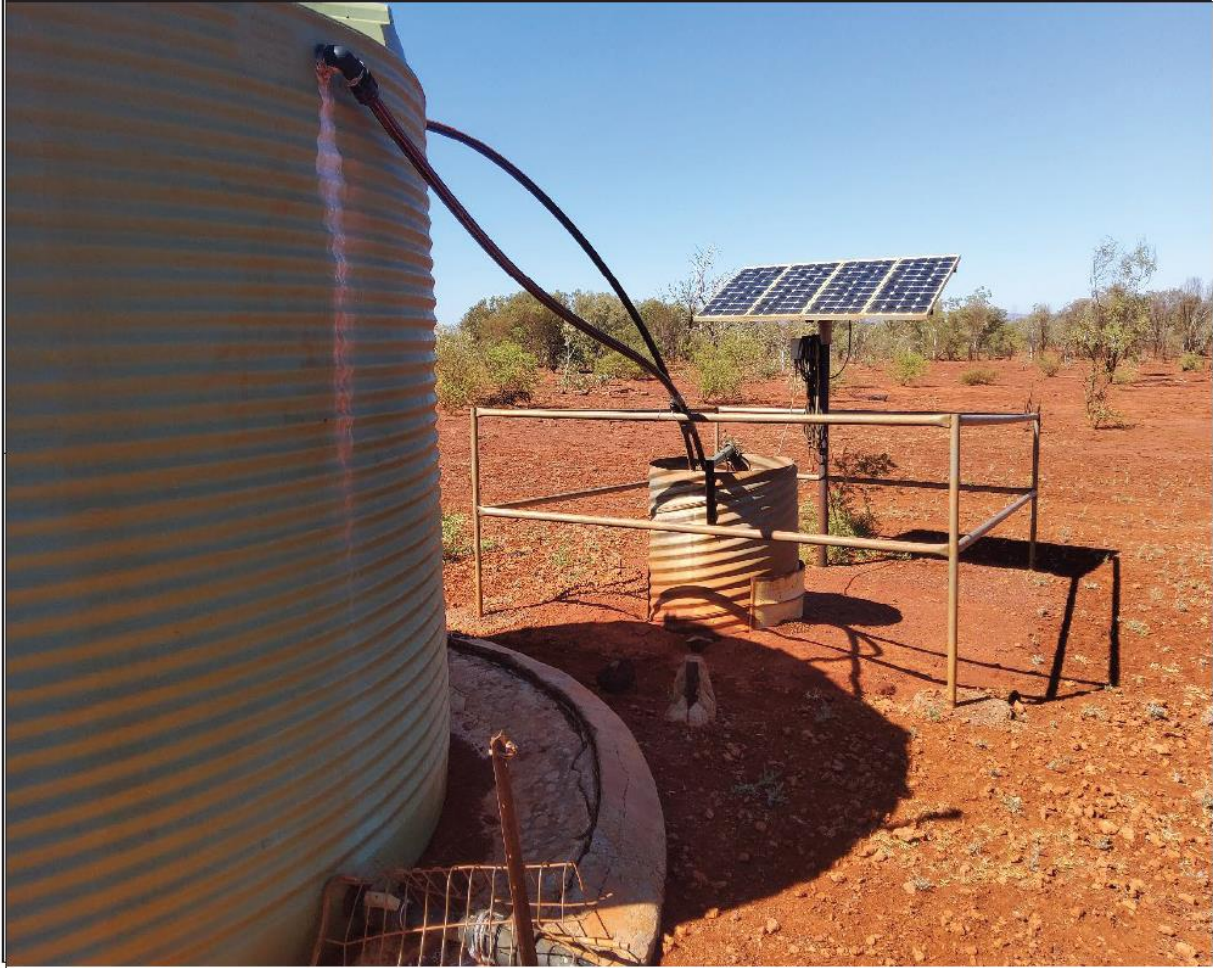
MURRAY'S WELL (PACM 6) – ASBESTOS DETECTED

**Visual Inspection –**  
Background two storage tanks. Foreground Storage Tank but evidence of cracking, weathering. Background, Bore and solar panel but no ACM identified.

**Laboratory Analysis –**  
Crocidolite asbestos detected.

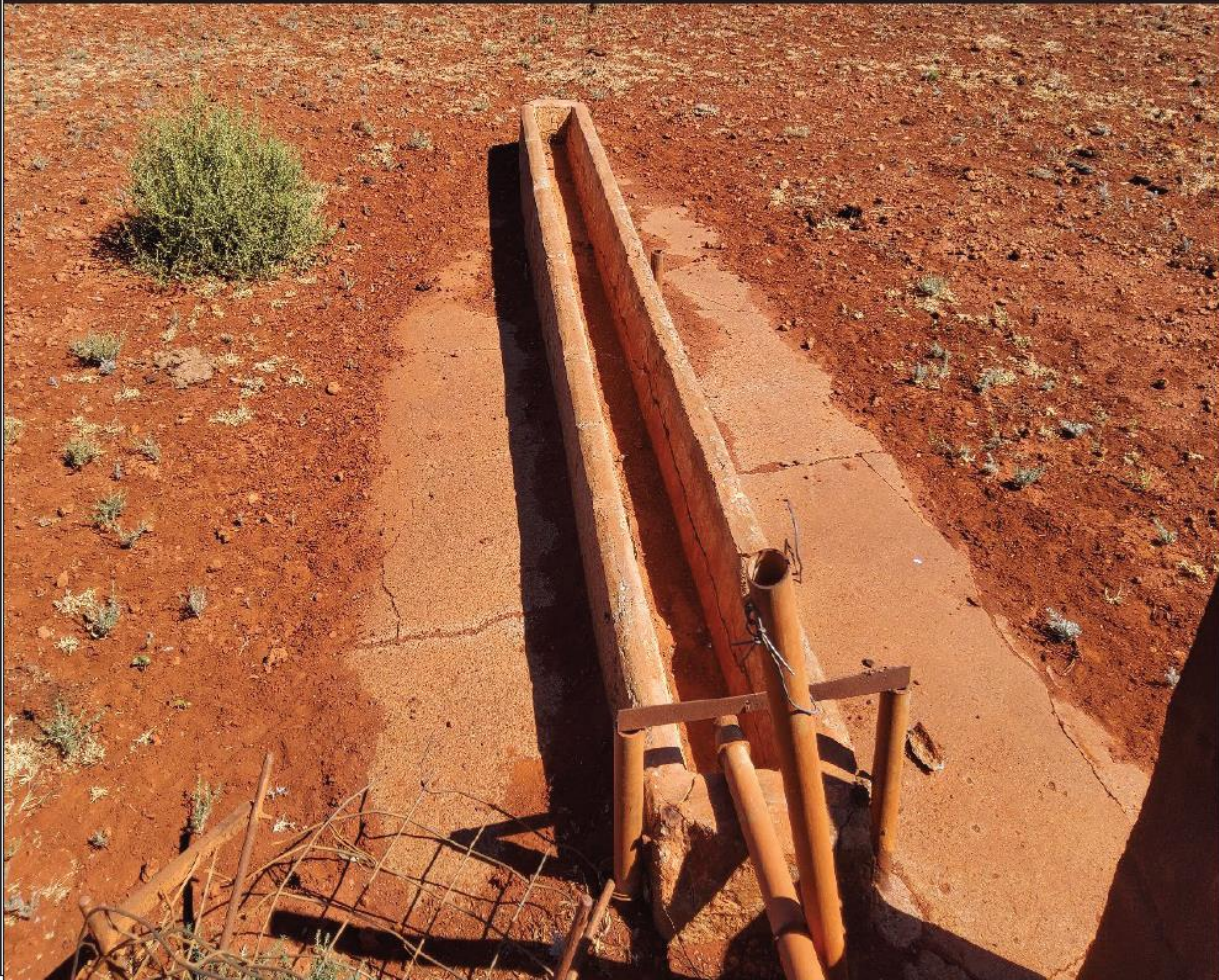
MURRAY'S WELL (PACM 6) – ASBESTOS DETECTED

**Visual Inspection –**  
Concrete trough,  
evidence of cracking,  
weathering. Potential  
ACM present.  
No fencing around  
structure.

**Laboratory Analysis –**  
Crocidolite asbestos  
detected.

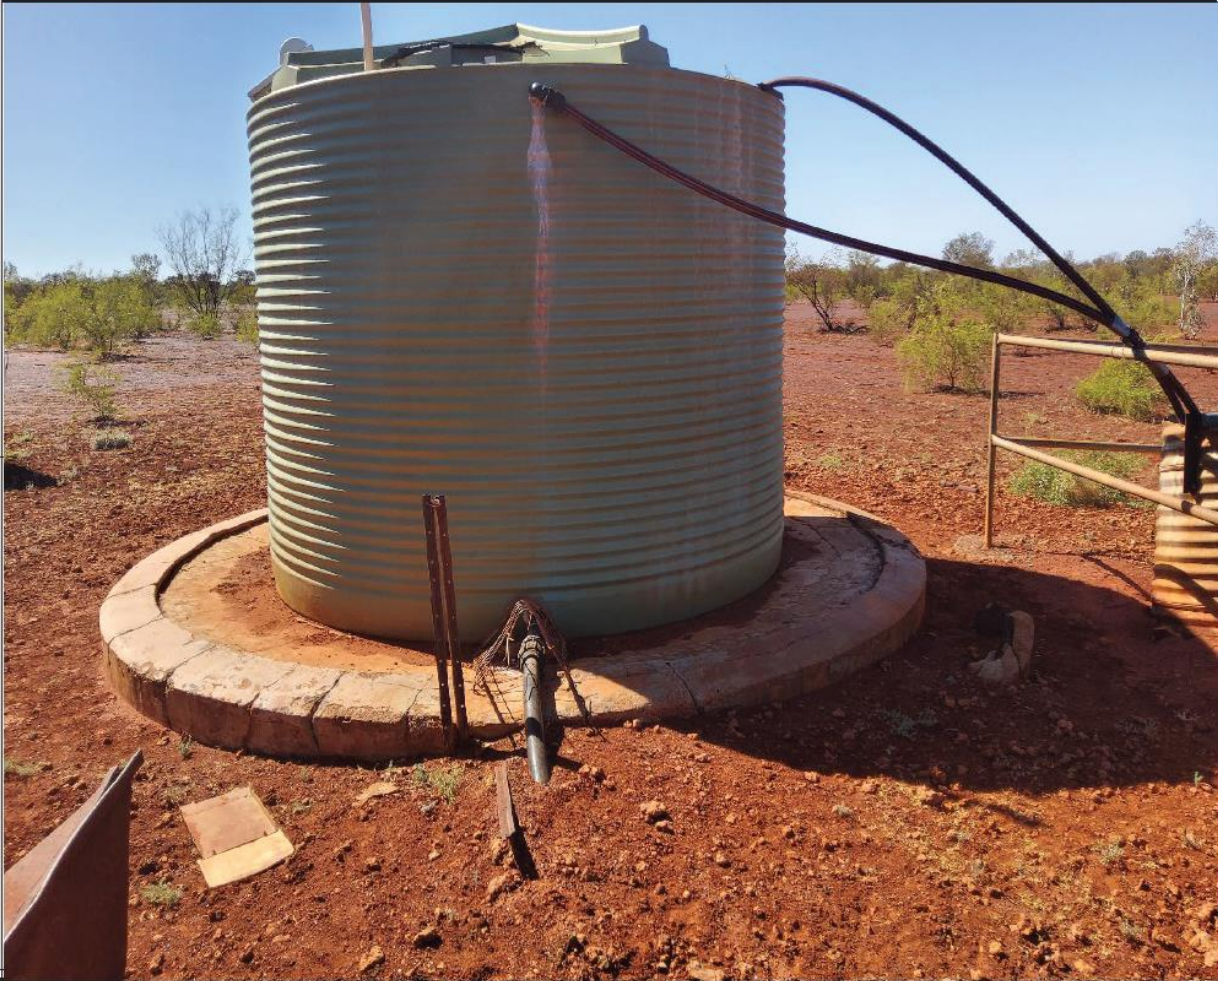
MURRAY’S WELL (PACM 6) – ASBESTOS DETECTED

**Visual Inspection –**  
Concrete tank stand, evidence of cracking, weathering.  
No fencing around structure.

**Laboratory Analysis –**  
Crocidolite asbestos detected.

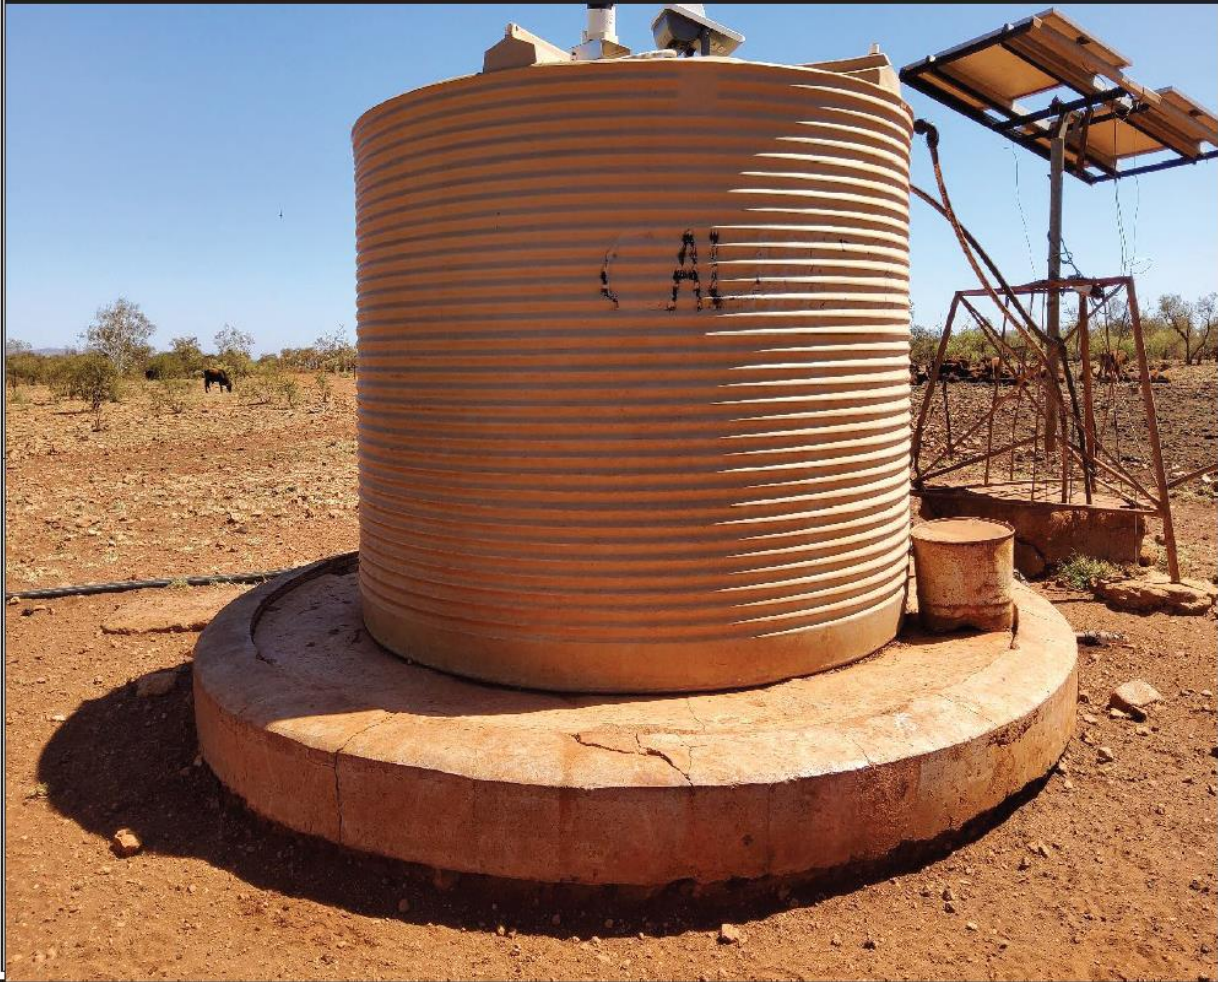
CALAMINA WELL (PACM 7) – ASBESTOS DETECTED

**Visual Inspection –**  
Concrete tank stand, evidence of cracking, weathering.  
No fencing around structure.

**Laboratory Analysis –**  
Crocidolite asbestos detected.

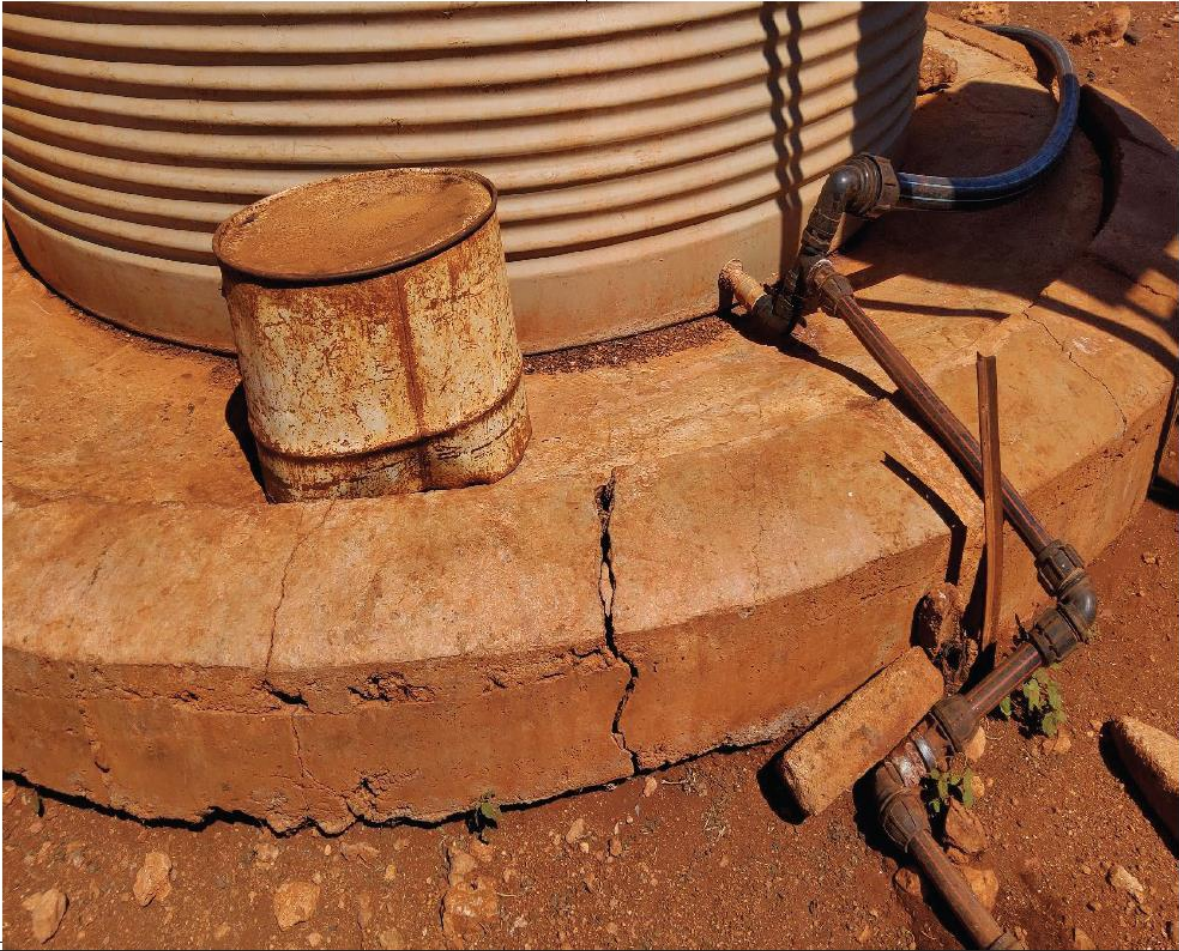
CALAMINA WELL (PACM 7) – ASBESTOS DETECTED

**Visual Inspection –**  
Concrete tank stand,  
evidence of cracking,  
weathering.  
No fencing around  
structure.

**Laboratory Analysis –**  
Crocidolite asbestos  
detected.

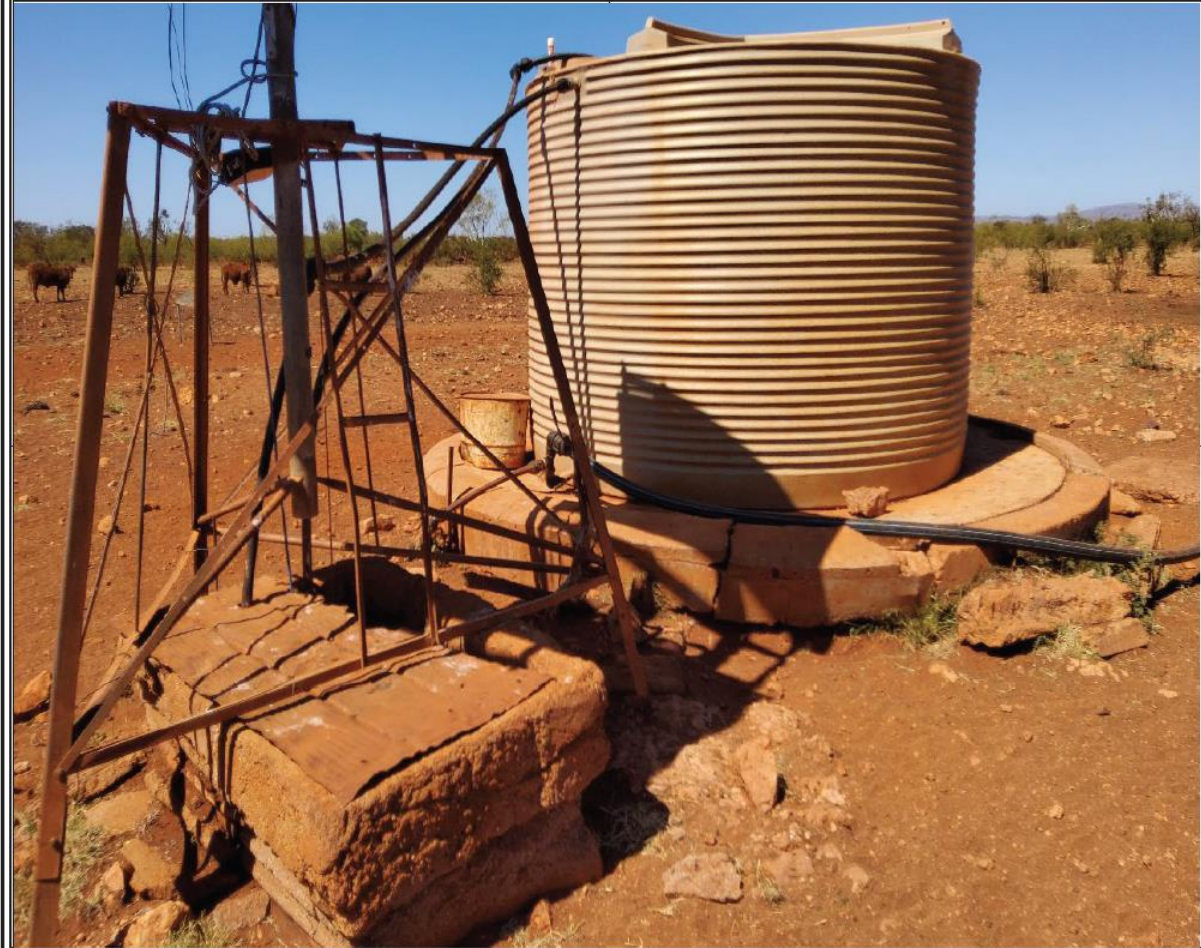
CALAMINA WELL (PACM 7) – ASBESTOS DETECTED

**Visual Inspection –**  
Concrete tank stand, evidence of cracking, weathering.  
No fencing around structure.

**Laboratory Analysis –**  
Crocidolite asbestos detected.

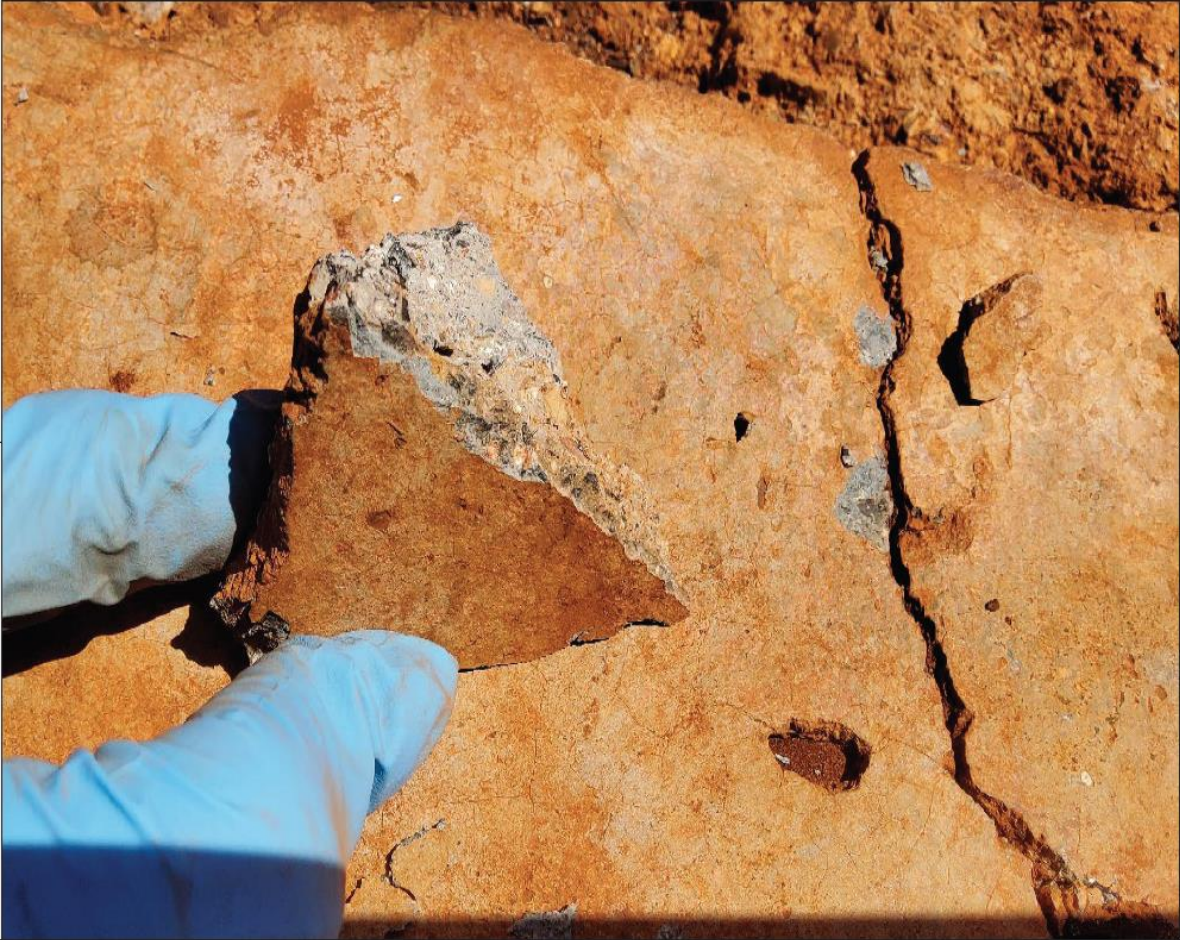
CALAMINA WELL (PACM 7) – ASBESTOS DETECTED

**Visual Inspection –**  
Fragment from concrete tank stand, evidence of cracking, weathering. No fencing around structure.

**Laboratory Analysis –**  
Crocidolite asbestos detected.
